**IMPROVING PEDESTRIAN  
SAFETY and MOBILITY  
at  
HARRIET TUBMAN  
TRIANGLE  
Harlem, New York**

**Report to  
Manhattan Borough President  
C. Virginia Fields**

by  
**KONHEIM & KETCHAM**  
in association with  
Michael King Architect and  
Transportation Alternatives

September 30, 2003

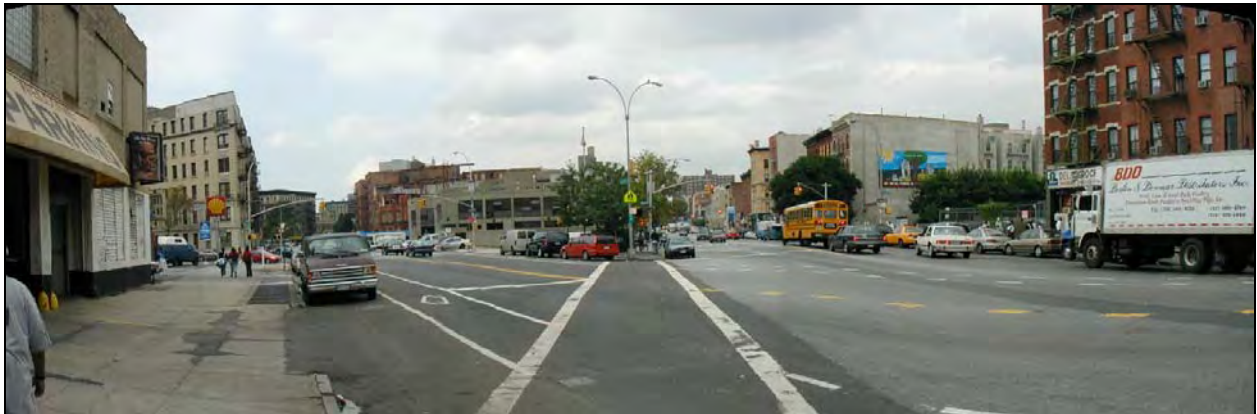
**Figure 1: View Looking North at Tubman Triangle**  
**Tubman Avenue on left, Douglass Boulevard on right**

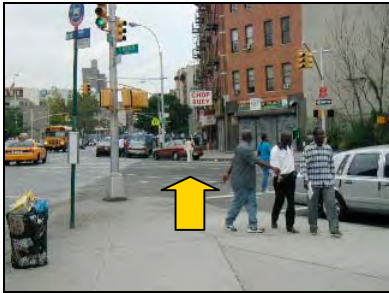
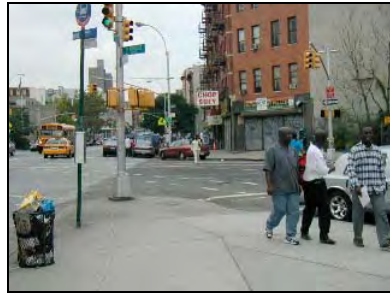
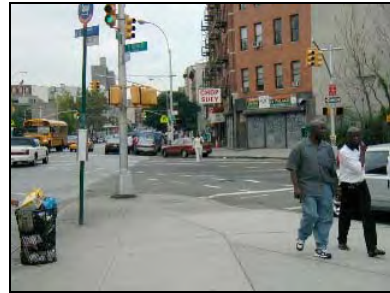
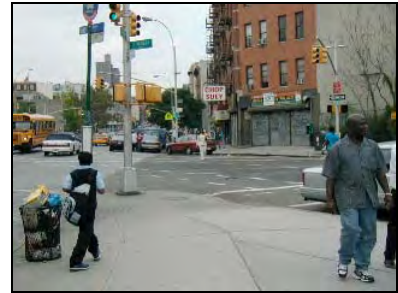
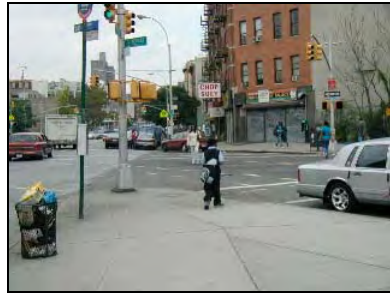
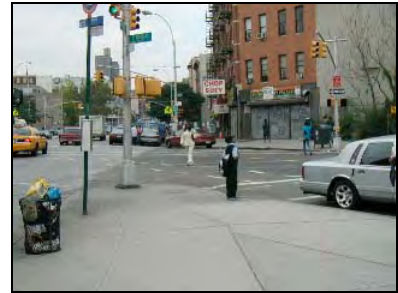
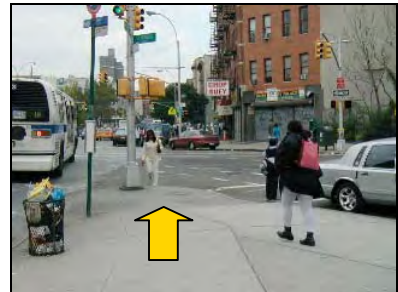
Figure 9: Time-lapse images of woman in white crossing Tubman Avenue

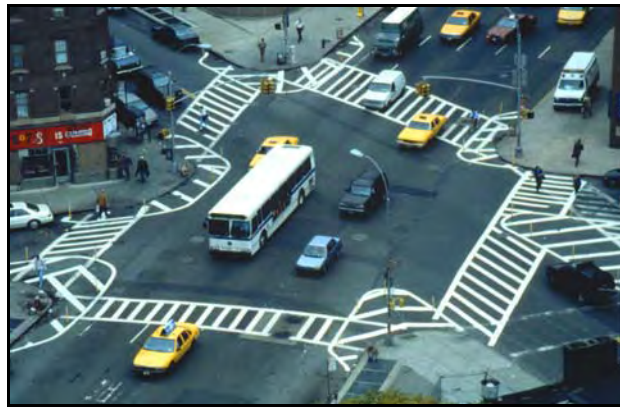
**Figure 17: Mulry Square pre-Curb Extension Markings<sup>17</sup>**

14. Set back the other stop lines at least eight feet to provide room for cyclists (especially those turning left) to queue ahead of waiting cars.
15. Mark the locations of the curb extensions and wider sidewalks described below in advance of their construction. This was done by DOT at Mulry Square in the mid-90's ahead of the recently completed curb extensions, see Figure 17.

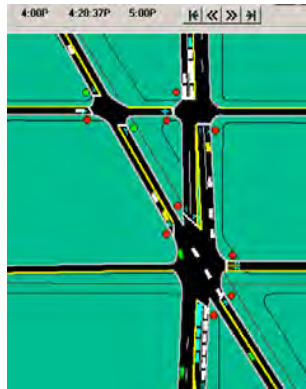
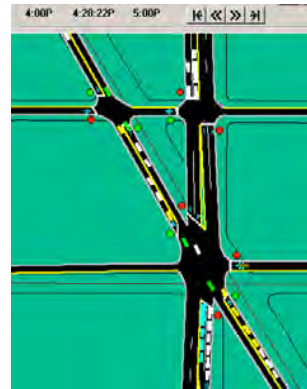
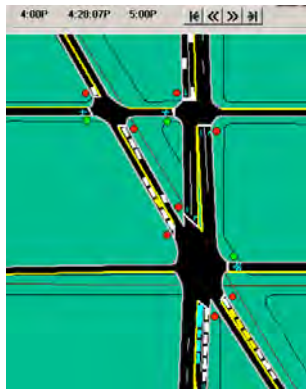
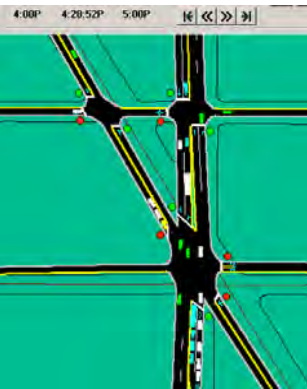
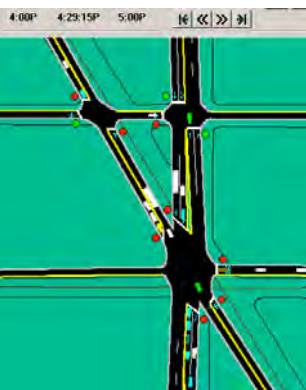
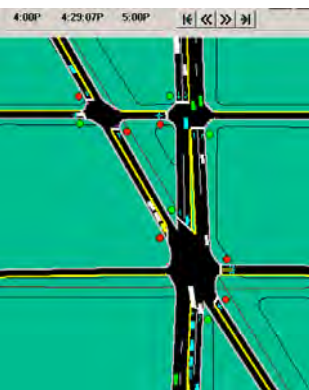
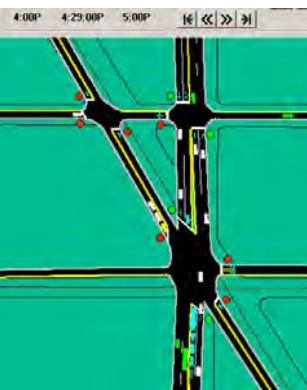
Figure 30: Simulation of PM Peak Traffic - Proposed
