Designing facilities for NMT users

Workshop report

Institute for Transportation and Development Policy
for the Institute of Urban Transport
20 August 2012

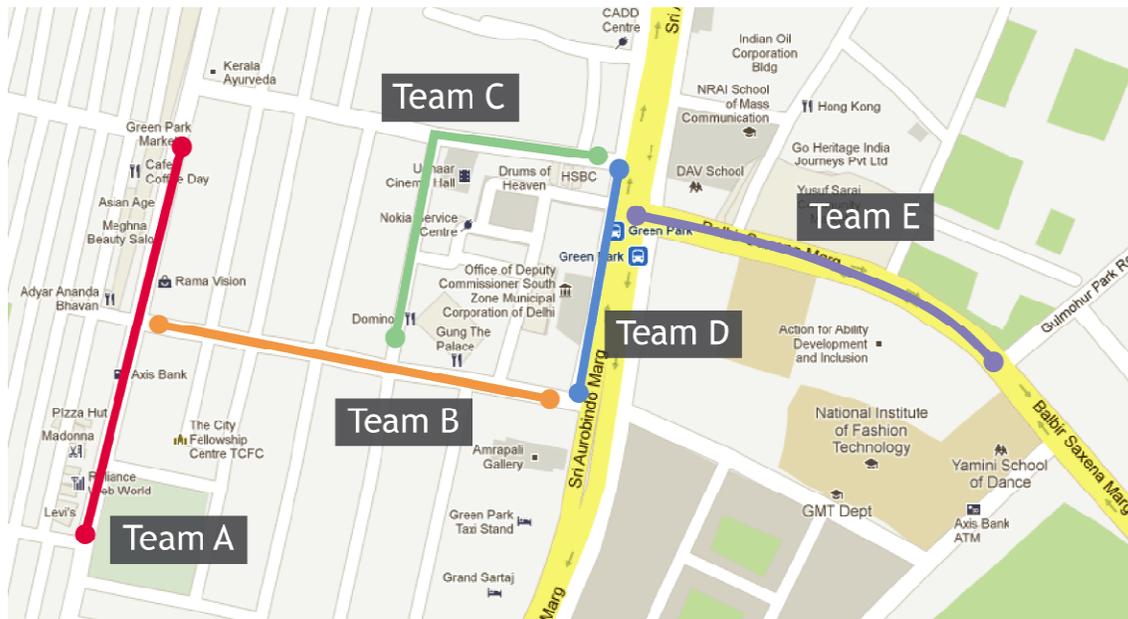
Team site visit locations in Green Park

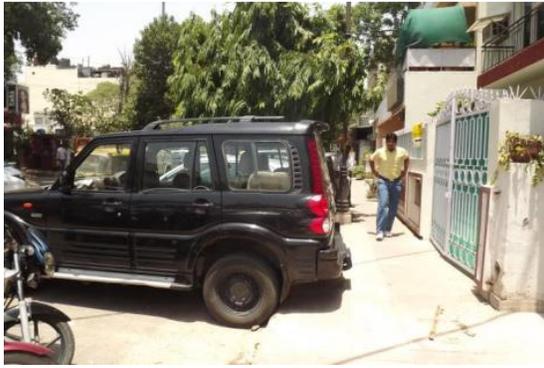
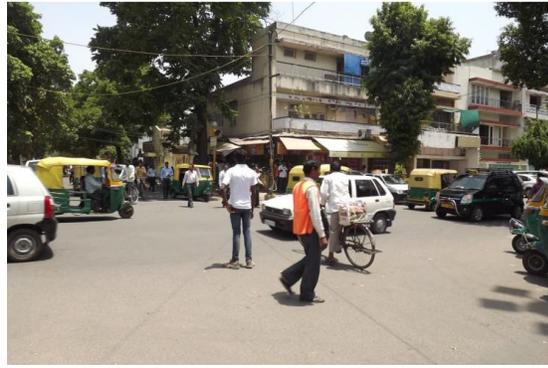
In the Green Park market area, pedestrian facilities are inadequate (left). At junctions, there are no formal pedestrian crossings (right).

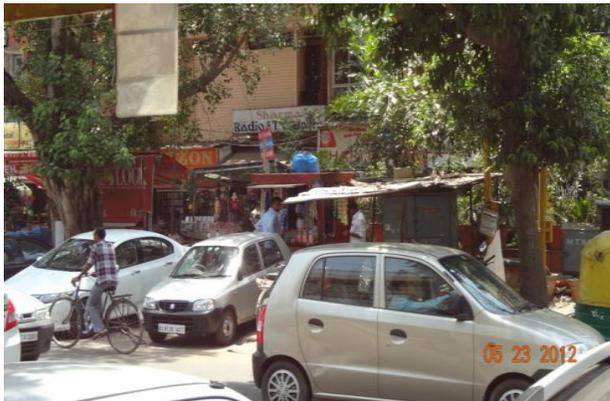
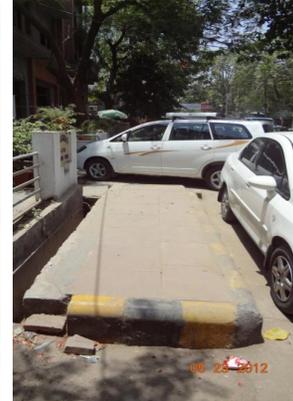
Team B observed that many residential buildings are now used as office and retail spaces (left). Footpaths are discontinuous and compromised by parking encroachments (right).

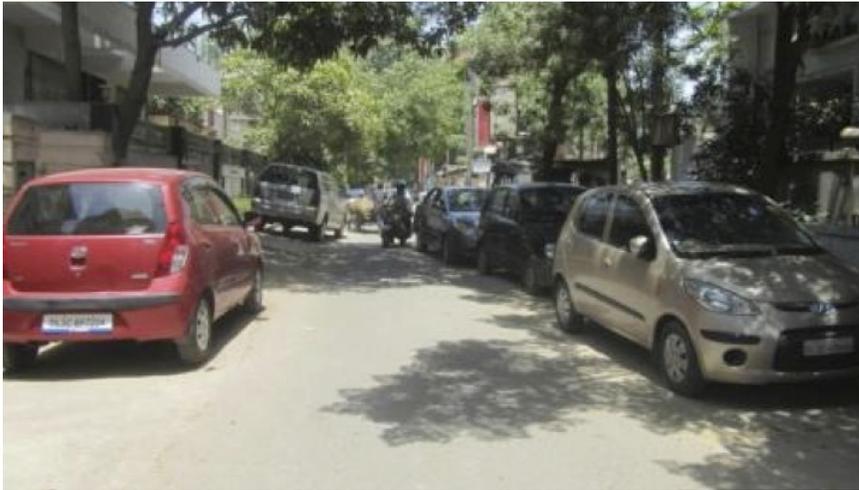
Team C observed heavy parking demand on Green Park’s interior streets. The narrow width allows the street to function as a safe shared space, and the mature tree canopy creates a comfortable environment for pedestrians and cyclists.

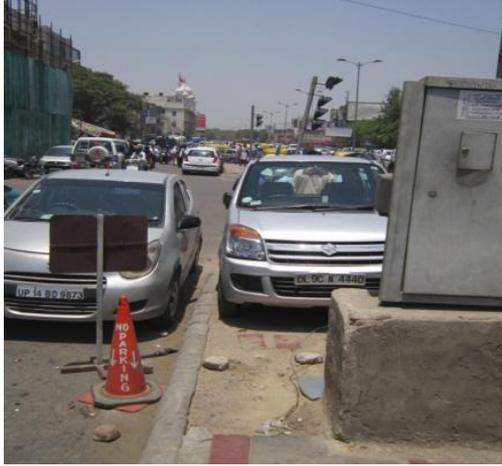
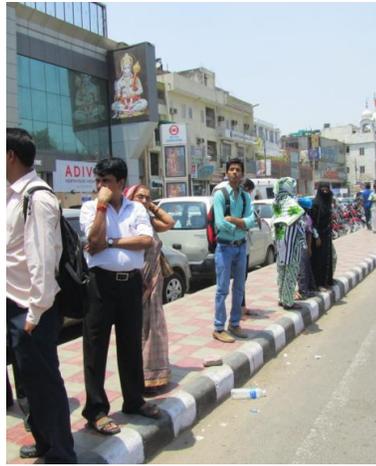
Utility boxes and parked cars prevent pedestrians from using the footpaths along Aurobindo Marg (left). The bus stop at the Green Park metro station (right) has neither a shelter nor identifying signage, forcing passengers to wait under the hot afternoon sun.

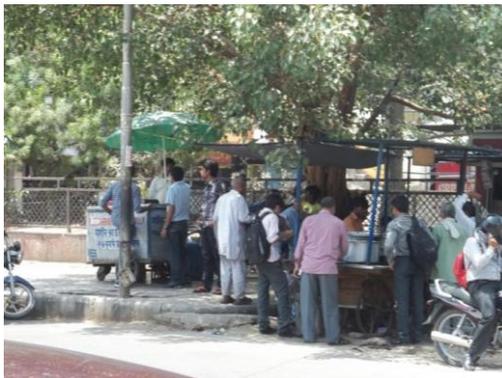
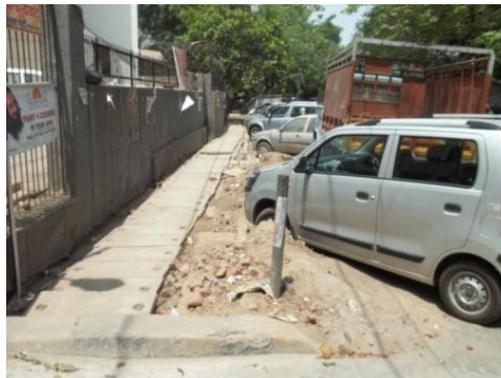
While some land uses in the study area have blank edges, street vendors serve as “eyes on the street” (left). Footpaths are poorly maintained (right).

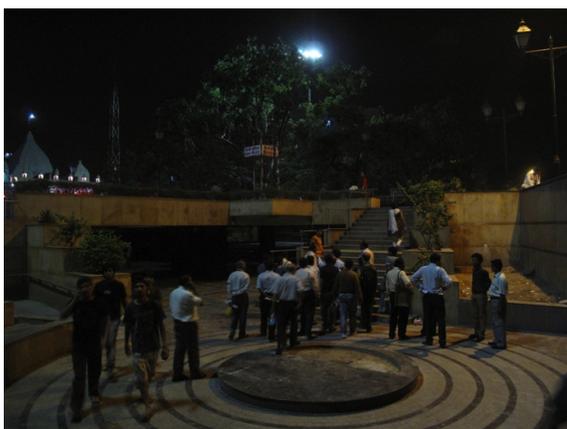
Participants on an evening site visit to a pedestrian subway on Baba Kharak Singh Marg.

- **Pedestrian crossings.** Participants visited intersection and midblock pedestrian crossings with different treatments. Near the Hanuman Mandir, a pedestrian subway was upgraded with the aim of improving safety and bringing more activity to the lower level. However, participants observed that the subway was poorly lit and that lower spaces were not being maintained. Elsewhere in Connaught Place, participants observed pedestrian crossings that were raised to the level of the footpath, forming a speed breaker for vehicles.

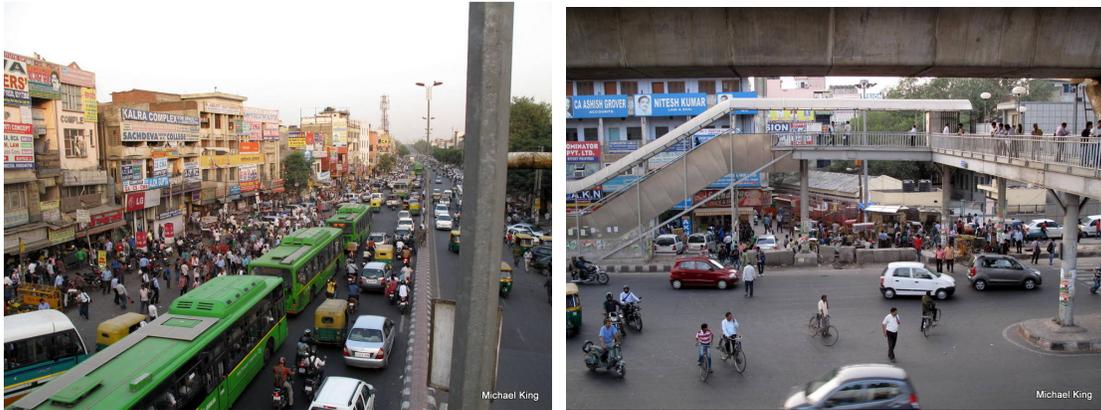
Heavy evening traffic at Laxmi Nagar intersection (left). In the absence of safe and convenient formal crossings, the intersection sees chaotic pedestrian movements in all directions (right).

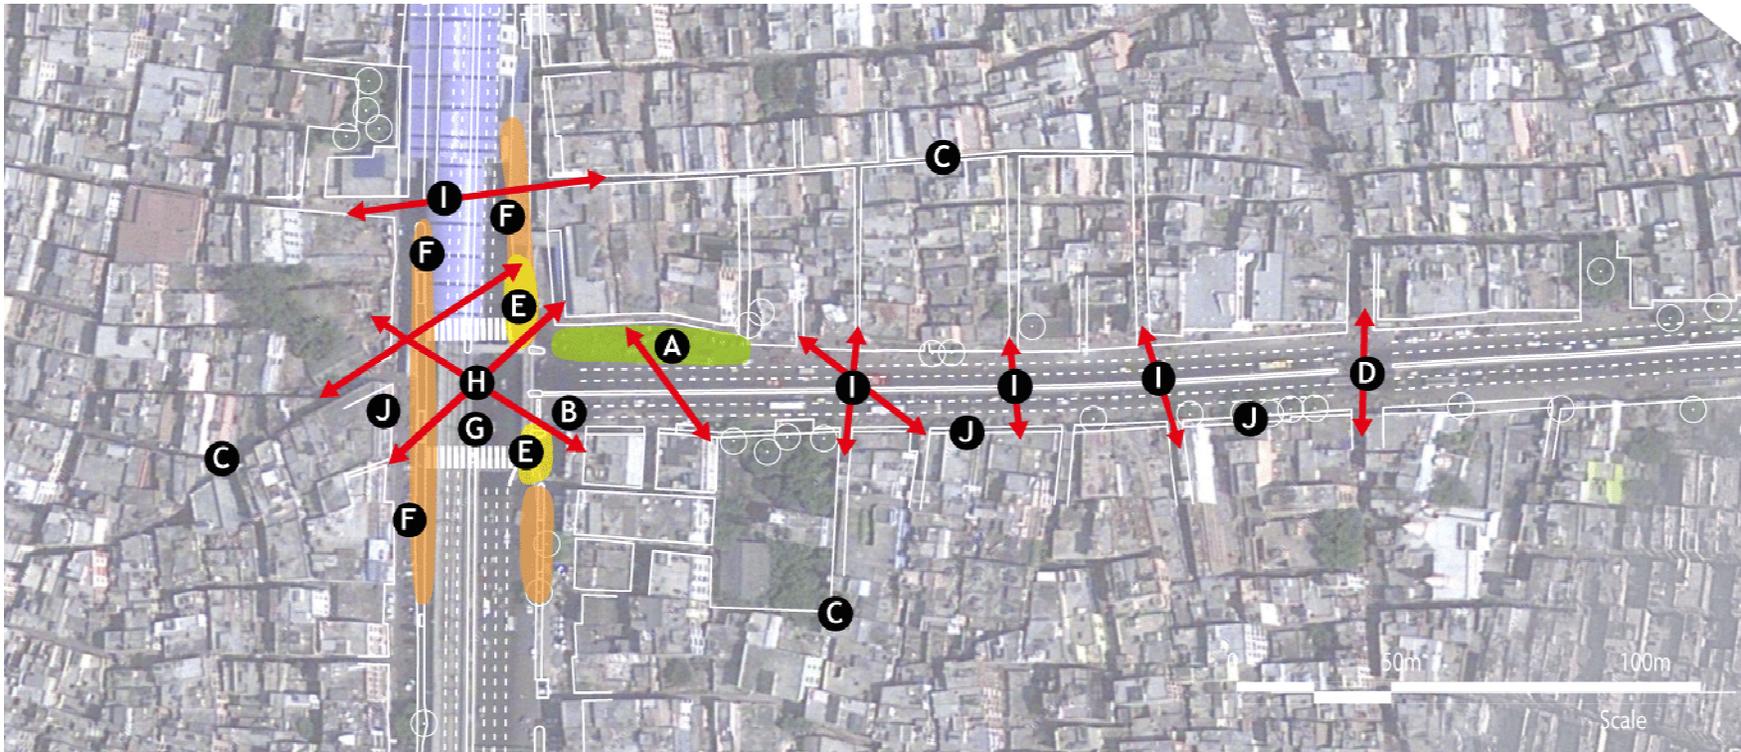
- A. Street space is poorly defined at the bus stop, with bus passengers and vendors jostling for space. There is an opportunity for a public plaza where the right-of-way broadens.

- B. The lack of a right turn from New Patpar Ganj Rd onto Vikas Marg impacts drivers and cyclists. Drivers have the option of using Old Patparganj Rd, but for cyclists and rickshaws making shot trips, the left turn is needed.

- C. The network of smaller streets should be integrated with street operations, especially for crossings.
- D. Pedestrian crossings at this junction need safety enhancements. The distance between this intersection and the main T-junction is over 200 m, which is too far for this location. At least one more formal pedestrian crossing should be added.

- E. Corners are ill-defined and allow drivers to make fast turns and block traffic.
- F. In several locations, the carriageway and service lane widen to provide space for parking, but this space is poorly managed and simply conflicts with other uses.

- G. Lanes at the junction need to be aligned and reduced to reflect permitted movements.
- H. Numerous diagonal pedestrian crossings need to be accommodated or eliminated.

- I. Midblock crossings, especially at smaller roads, need to be allowed and enhanced. Medians need to be widened to properly protect pedestrians crossing.

- J. Space along buildings is ill-defined and could be cleaned up.
